**RENEWAL SURVEY REPORT FOR LOT 2 L.R. 276 PN: 190-
001-0072 AT
TAKABORI WEST GUADALCANAL.**

Prepared for the Client:
The Solomon Islands National University

Prepared by:
32D Surveying & Engineering Firm
Honiara
Phone: 677 78 70096
Email: 32dsurveying@gmail.com

01th August 2025

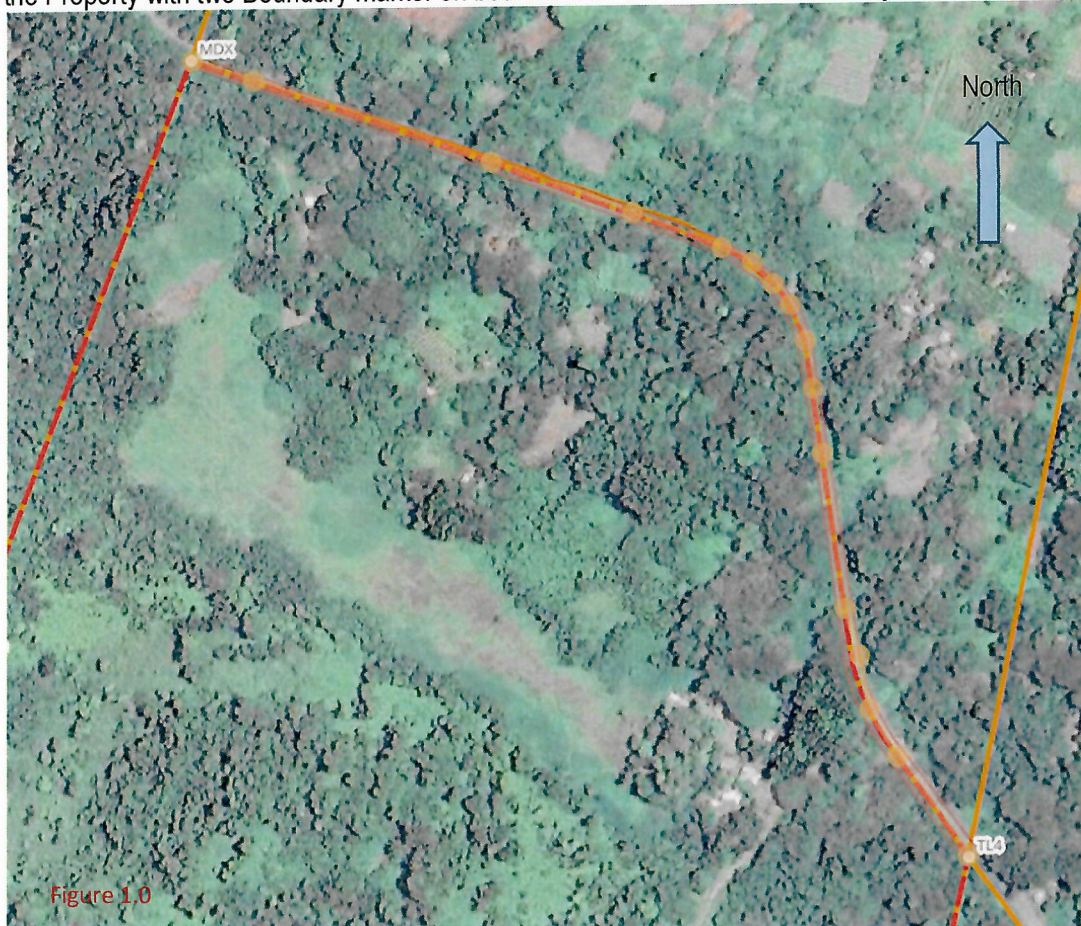
Figure 1.0

The main access road runs at 857.694 m from east to west of Lot 2 and is Located on the North Frontage of the Property with two Boundary marker on both ends on the centre line indicatory as the Property line.

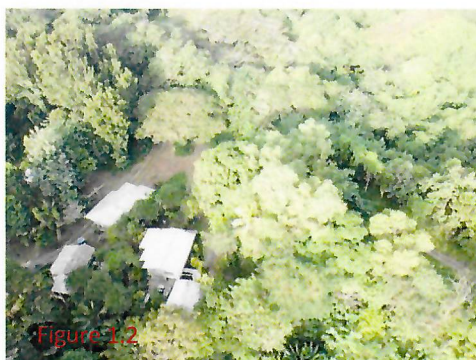
Figure 1.2

There are 21 existing building structures located on the property with some been permanent to home man structures. They are located using drone aerial and pickup from GNSS i89 rover. (See attach drawing Appendix 3)

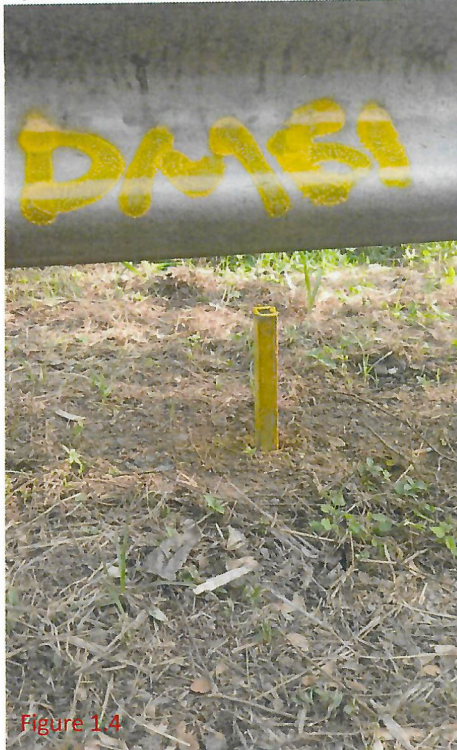
Figure 1.4

For the frontage the Centreline boundary markers MDX and TL4 are identified on the road as shown on the following (figures 1.4 & Figure 1.5). MDX is marked with a 50cm square cube rod and tagged with yellow spray paint and TL4 is marked up with yellow spray mark on the road bitumen.

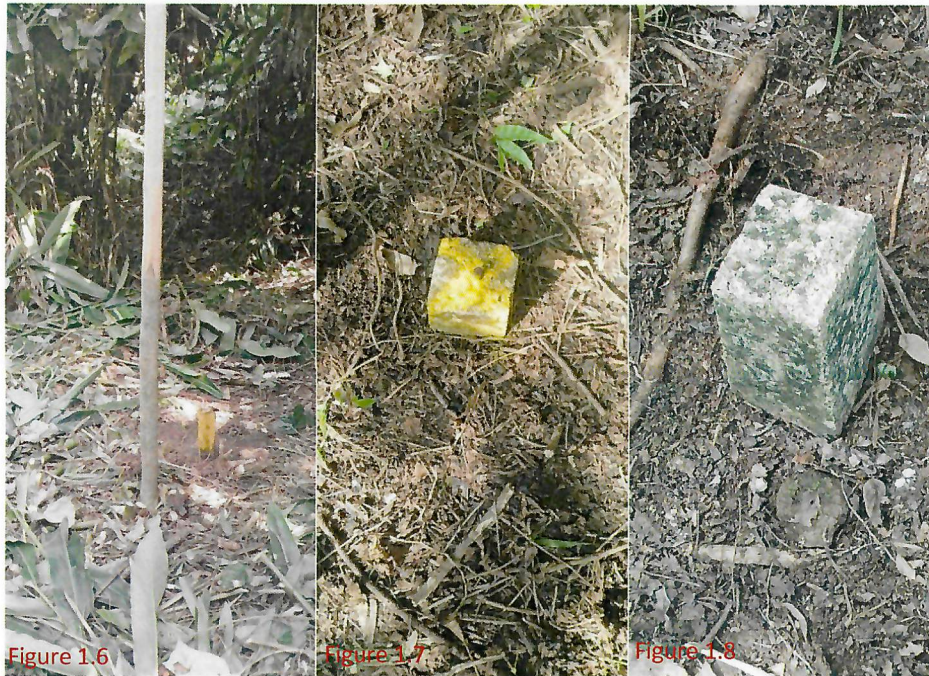
The western end boundary markers MD9, MD5 and MD59 are found in their fixed position. MD9 is a u rod in concrete found in good condition (Figure 1.6 & Figure 1.7); MD5 and MD59 are also found in good condition and both a concrete 100mmX100mm with a still rod in the centre (Figure 1.8)

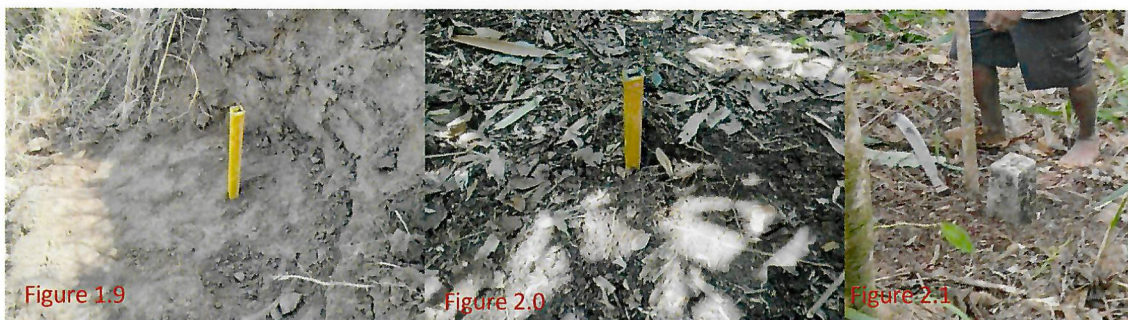
For the Back boundary markers; P75 (Figure 1.9); is not found on its original coordinate and it is replaced by a square rod in grounded and marked up with yellow tagged spray paint. P76 however is find in good fixed condition (concrete 100mmX100mm rod in center- Figure 2.0); For the unknown intersection (ISP) line (Figure 2.1); an indicatory mark a square cube rod in placed and tagged yellow spray marked up.
